**Flood Control Project Maintenance
Levee Inspections**

Fall 2018 Levee Maintenance Deficiency Summary Report

San Joaquin River Basin

Reclamation District No. 2085 Kasson

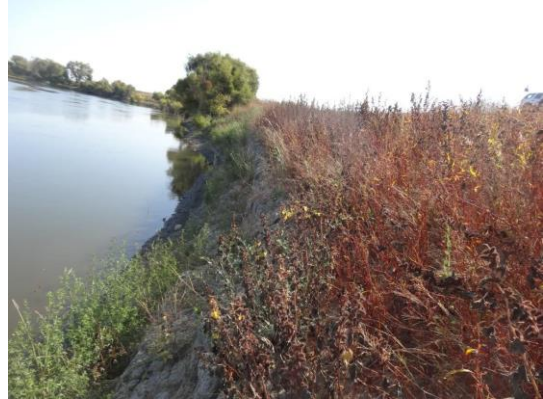
Photo 1 of 4 : FA_2018_RD2085_113_1_20180911_00001.jpg

Looking upstream at the erosion site. Note the dense vegetation and the trees at the upstream of the erosion.

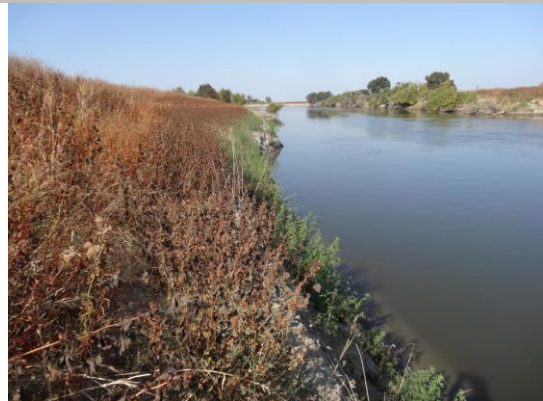
Photo 2 of 4 : FA_2018_RD2085_113_1_20180911_00002.jpg

Looking downstream at the erosion site.

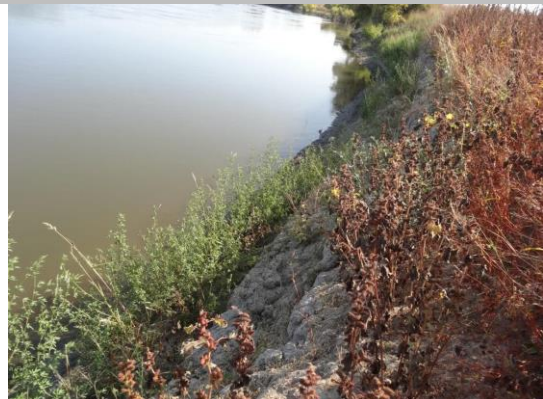
Photo 3 of 4 : FA_2018_RD2085_113_1_20180911_00003.jpg

Close view of the erosion.

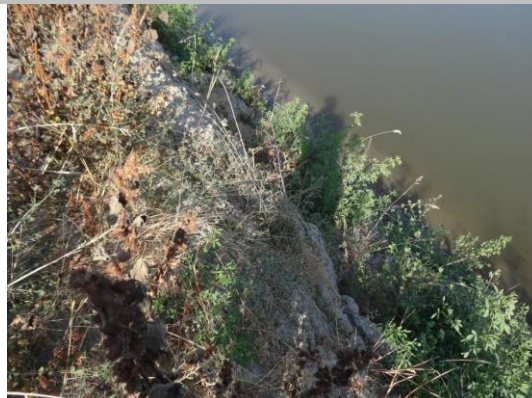
Photo 4 of 4 : FA_2018_RD2085_113_1_20180911_00004.jpg

Close view of the erosion.

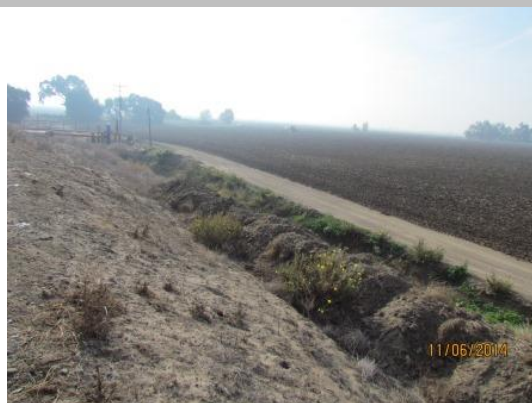
Photo 1 of 1 : FA_2018_RD2085_113_6_20180911_00010.jpg

LM Start	1.34	Rating **	M	Issue No.	6
LM End	1.38	Issue Type +	En	Location *	LS
Category	Earthen Levee			GPS Latitude/Longitude	
				Start	End
Item	Encroachments			37.714265 °	37.714056 °
				-121.289641 °	-121.289069 °
DWR ID	DWR_RD2085_01_s_2012_6				
Comment Code					
DT : Ditch					
Inspector Comment					
Drainage ditch at levee toe.

View of the ditch at the landside levee toe.

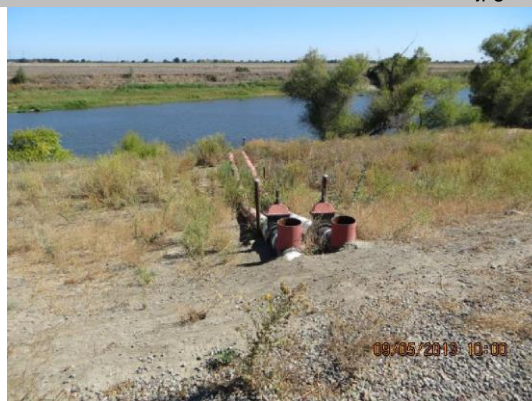
Photo 1 of 3 : UCIP_FA_2018_22285_38010.jpg

LM Start	1.35	Rating **	M	Issue No.	53	
LM End	1.35	Issue Type +	En	Location *		
Category	Supplemental			GPS Latitude/Longitude		
				Start	End	
Item	DWR UCIP Field Study			37.714404 °	37.714404 °	
				-121.289469 °	-121.289469 °	
DWR ID	24055					
Comment Code						
Inspector Comment						
FS_ID:22285						
DS_ID:24055						
EP_NO: N/A						
Repair Type: Non-Urgent						
Crossing Status: Found						
UCIP Comments: No permit identified for this modified crossing.						
FIELD_STRUCT_DESC: 12-inch steel drainage pipe through the levee, 3 feet below the crown. Pump mounted on pile structure in ditch on the landside (LS). Gate valve and siphon breaker in a 12-inch steel riser on the waterside (WS) shoulder. (Permit No. 8189, 1972 - Reclamation District No. 2085).						
FS Date: 9/10/2013

Pipe, gate valve, and siphon breaker visible on WS slope.

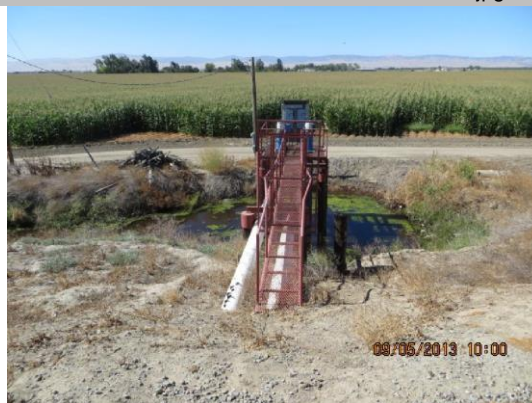
Photo 2 of 3 : UCIP_FA_2018_22285_38009.jpg

Pipe, pump, and walkway visible on LS toe.

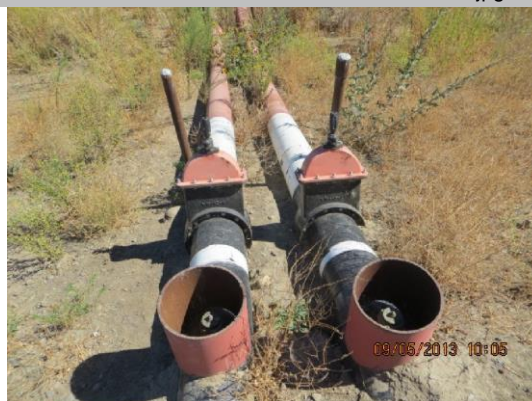
Photo 3 of 3 : UCIP_FA_2018_22285_38008.jpg

Pipe, gate valve, and siphon breaker visible on WS slope.

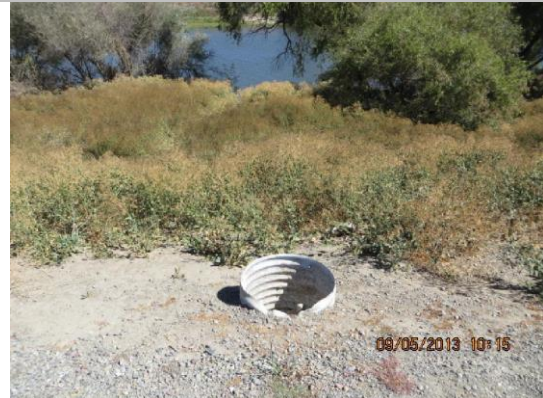
Photo 1 of 3 : UCIP_FA_2018_41351_62268.jpg

Comment Code						
Inspector Comment						
FS_ID:41351						
DS_ID:20679						
EP_NO: 3975						
Repair Type: Non-Urgent						
Crossing Status: Found						
UCIP Comments: Pipe abandoned and should be done so properly.						
Large hole in ground over pipe on WS berm. Pipe rusted through on						
WS at river bank. No connection to pump on LS toe.						
FIELD_STRUCT_DESC: *ABANDONED* 10-inch steel drainage pipe						
through the levee, 4 feet below the crown. Steel plate over pipe end at						
pump station on the landside (LS) toe. Siphon breaker in a 24-inch						
corrugated metal pipe (CMP) riser on the waterside (WS) shoulder.						
(Permit No. 3975, 1962 - Glenn West Trust). [Additional Reference(s):						
DWR Levee Log, 2005. USACE San Joaquin O&M Manual 11, 1968,						
(HLM 1.35)].						
FS Date: 9/5/2013

Siphon breaker in 24-inch CMP riser on WS shoulder.

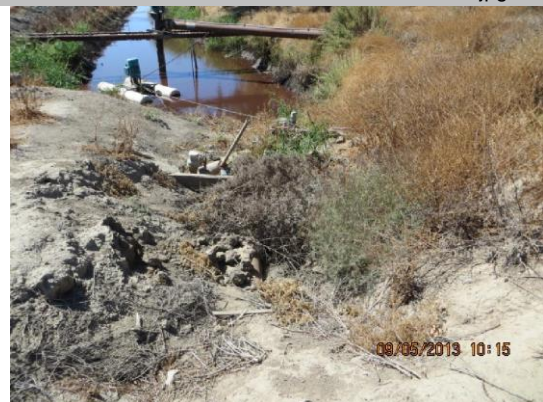
Photo 2 of 3 : UCIP_FA_2018_41351_62267.jpg

Pipe visible at bottom of ditch on LS toe.

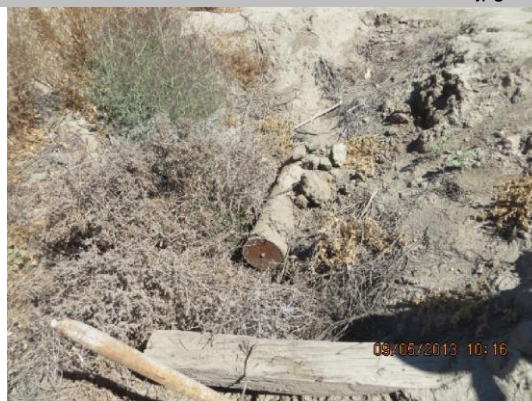
Photo 3 of 3 : UCIP_FA_2018_41351_62266.jpg

Pipe visible at bottom of ditch on LS toe.

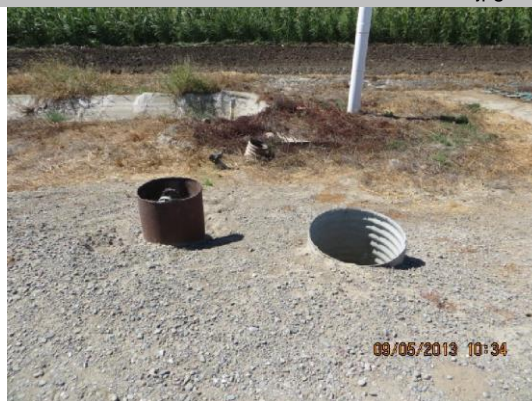
Photo 1 of 3 : UCIP_FA_2018_19423_32962.jpg

LM Start	2.04	Rating **	M	Issue No.	55
LM End	2.04	Issue Type +	En	Location *	
Category	Supplemental			GPS Latitude/Longitude	
				Start	End
Item	DWR UCIP Field Study			37.708826 °	37.708826 °
				-121.279271 °	-121.279271 °
DWR ID	20681				
Comment Code					
Inspector Comment					
FS_ID:19423 DS_ID:20681 EP_NO: N/A Repair Type: Non-Urgent Crossing Status: Found UCIP Comments: This pipe is abandoned and should be done so properly. FIELD_STRUCT_DESC: 1 of 2: 10-inch pipe through the levee 2.0-feet below the crown. Pump mounted on pile structure in the river. Siphon breaker in 24-inch CMP riser on the LS slope. Power pole on LS toe. Wooden stairs and walkway from the berm to the pump structure. Originally included in the 1968 O&M manual. FS Date: 9/5/2013 8:22:24 AM

Siphon breaker in 24-inch CMP riser on LS slope. Possible gate valve at end of concrete channel on LS toe.

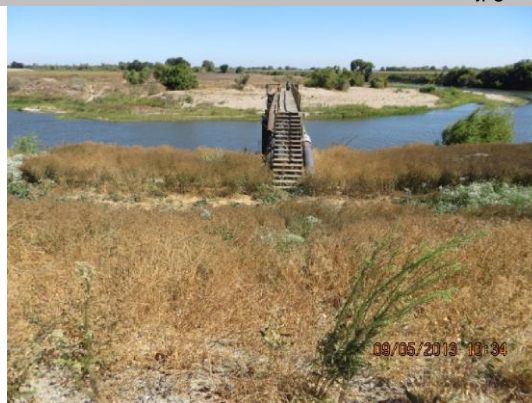
Photo 2 of 3 : UCIP_FA_2018_19423_32961.jpg

Pipe cut at wooden pier. No pump on end of pier for this pipe.

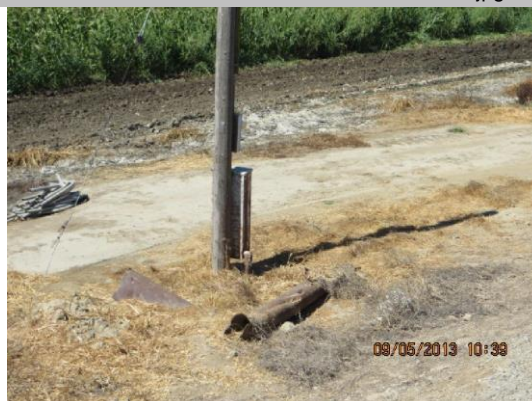
Photo 3 of 3 : UCIP_FA_2018_19423_32960.jpg

Power pole on LS toe.

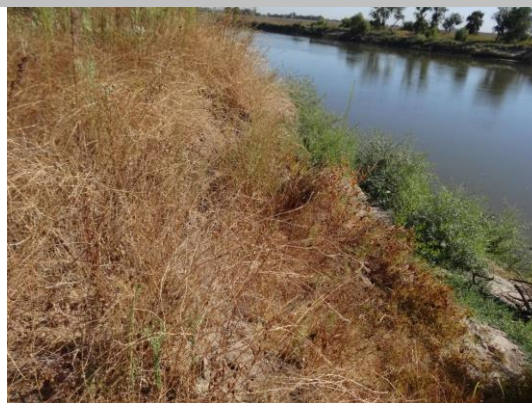
Photo 1 of 4 : FA_2018_RD2085_113_2_20180911_00005.jpg

Comment Code					
Inspector Comment					
11/1/2018: This site was repaired within the past week.					
10/04/2017: The erosion has progressed significantly toward the levee toe.					
07/08/2016: No significant change observed.					
09/10/2015: No significant change observed. Signs of animal activity are present.					
09/10/2014: No significant change observed.					
09/20/2013: No significant change in erosion observed. More vegetation at the site.					
12/04/2012: The erosion has progressed remarkably toward levee, extended to the up-and downstream of the original pocket erosion. Trees and dense bush are present at the site. Animal burrow holes are visible, and possibly can cause seepage.					
09/22/2010: No significant change observed. There is little visibility due to seasonal grass on the berm and slope.					
08/18/2009: Site is located on berm; pocket erosion has developed; the site is covered in dense vegetation; there are several relief wells on the landside of the levee; site is Not Rated because berm width is greater than 30 feet; site should be monitored to keep track of erosion progress. [2017 Site ID:RD2085U01RM66.5]

Close view of the erosion. Note the dense vegetation at the site.

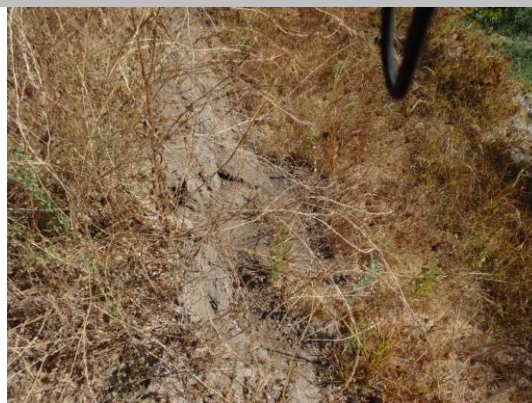
Photo 2 of 4 : FA_2018_RD2085_113_2_20180911_00006.jpg

Close view of the erosion.

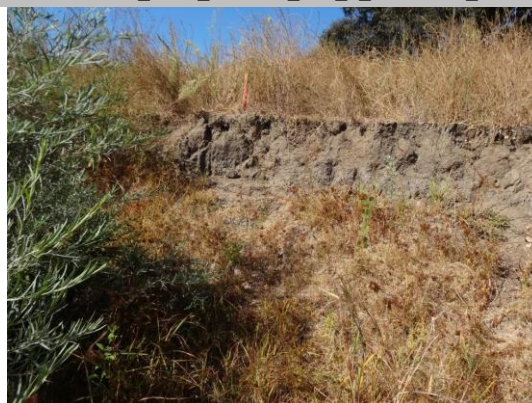
Photo 3 of 4 : FA_2018_RD2085_113_2_20180911_00007.jpg

Direct view of the erosion. Note the sign of erosion expansion.

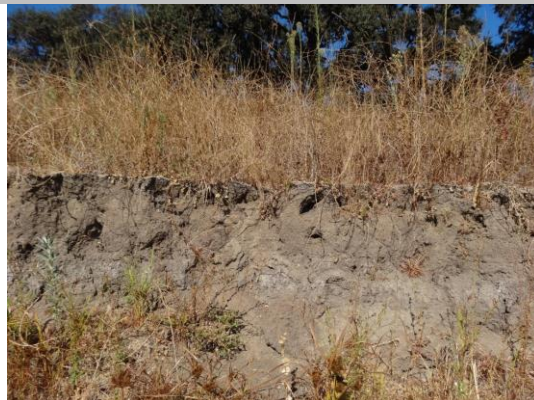
Photo 4 of 4 : FA_2018_RD2085_113_2_20180911_00008.jpg

Close view of the erosion.

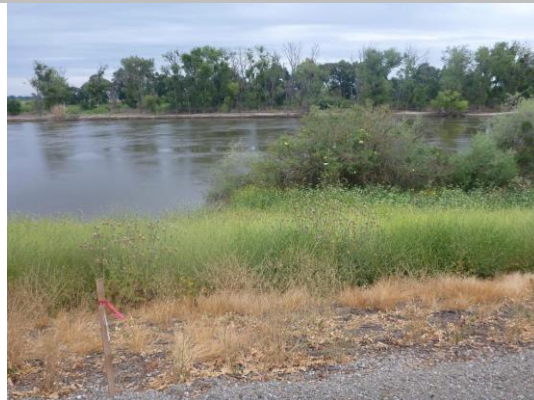
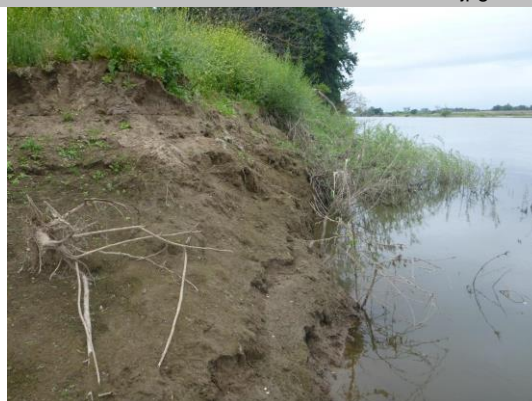
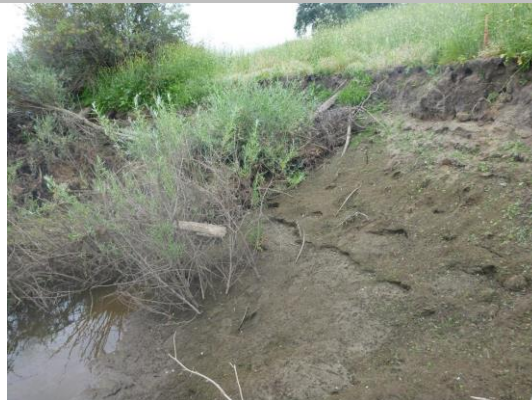
LM Start	2.57	Rating **	A/W	Issue No.	48	
LM End		Issue Type +	Ma	Location *		
Category	Supplemental			GPS Latitude/Longitude		
				Start	End	
Item	2017 Storm Damage			37.703094 °		°
				-121.274894 °		°
DWR ID	DWR_RD2085_01_f_2017_48					
Comment Code						
Inspector Comment						
Levee Evaluation Comments						
Description:						
Site ID No:105						
Site Designation:FSRP-13-55						
Repair Type: Erosion						
Rating:Serious						
Field Date:6/8/2017						
Notes: This site is repaired as of this inspection date. Fall 2018.

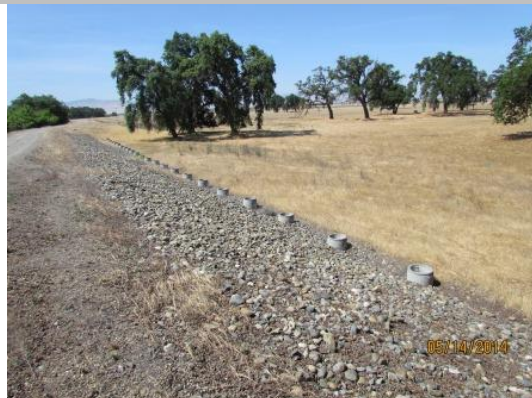
Photo 1 of 1 : FA_2018_RD2085_113_20_20180911_00012.jpg

View of the underseepage relief wells at the landside levee toe.

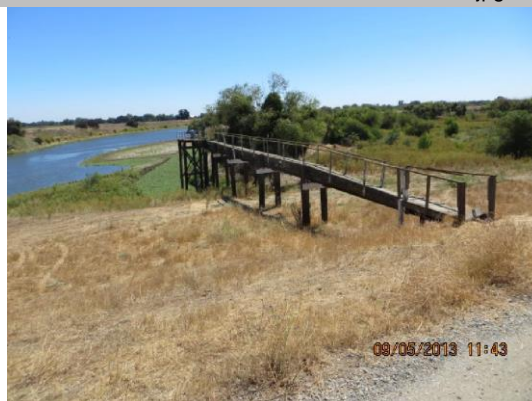
Photo 1 of 3 : UCIP_FA_2018_19431_32983.jpg

LM Start	2.82	Rating **	M	Issue No.	56
LM End	2.82	Issue Type +	En	Location *	
Category	Supplemental			GPS Latitude/Longitude	
				Start	End
Item	DWR UCIP Field Study			37.699698 °	37.699698 °
				-121.276325 °	-121.276325 °
DWR ID	20688				
Comment Code					
Inspector Comment					
FS_ID:19431					
DS_ID:20688					
EP_NO: 16970					
Repair Type: Non-Urgent					
Crossing Status: Found					
UCIP Comments: The wooden walkway on the WS slope is in disrepair.					
FIELD_STRUCT_DESC: 1 of 2: 14-inch steel irrigation pipe through the					
levee, 2 feet below the crown. Pump on wooden pier on the waterside					
(WS) slope. Siphon breaker visible next to steel bollard on the landside					
(LS) slope. Power pole on the LS toe. [Additional Reference(s): USACE					
San Joaquin O&M Manual 11, 1968, (HLM 2.74)].					
FS Date: 9/5/2013

Pump on Wooden pier at WS slope.

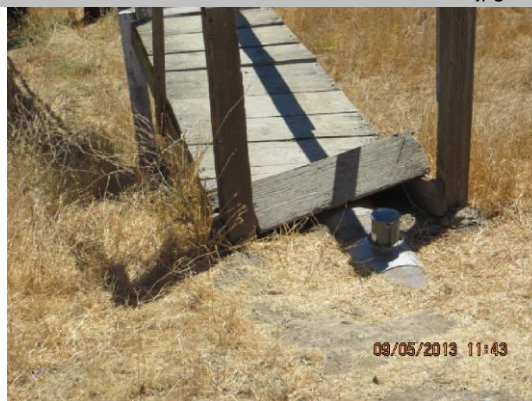
Photo 2 of 3 : UCIP_FA_2018_19431_32982.jpg

Pipe visible under walkway on WS slope.

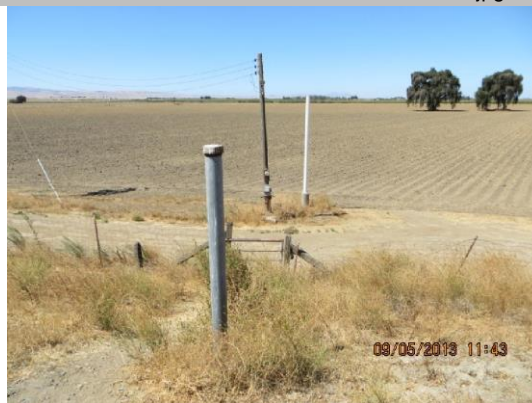
Photo 3 of 3 : UCIP_FA_2018_19431_32981.jpg

Power pole on LS toe with possible PVC riser.

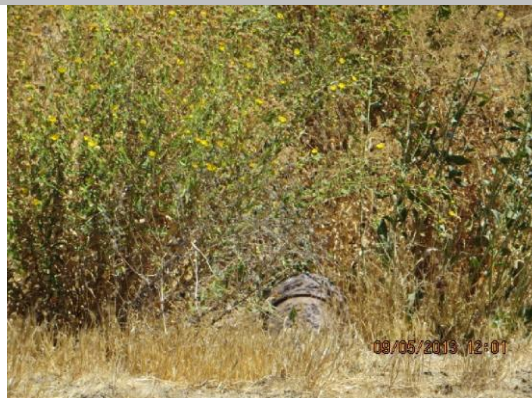
Photo 2 of 3 : UCIP_FA_2018_19433_32989.jpg

Pipe visible on WS slope.

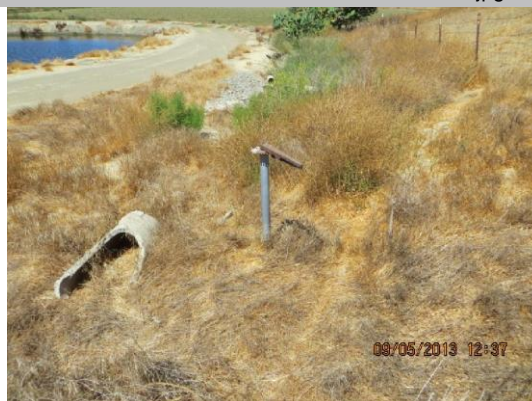
Photo 1 of 3 : UCIP_FA_2018_19435_32993.jpg

LM Start	3.42	Rating **	M	Issue No.	58	
LM End	3.42	Issue Type +	En	Location *		
Category	Supplemental			GPS Latitude/Longitude		
				Start	End	
Item	DWR UCIP Field Study			37.691966 °	37.691966 °	
				-121.278122 °	-121.278122 °	
DWR ID	20687					
Comment Code						
Inspector Comment						
FS_ID:19435 DS_ID:20687 EP_NO: 16970 Repair Type: Non-Urgent Crossing Status: Found UCIP Comments: Appears abandoned and if so should be done so properly. FIELD_STRUCT_DESC: *ABANDONED* 2 of 2: 10-inch steel drainage pipe through the levee, 2 feet below the crown. Appears to connect to pump 150 feet off the landside (LS) toe. Possible butterfly valve at the LS toe. Vent on the waterside (WS) shoulder. Steel plate welded over pipe end on the WS toe. FS Date: 9/5/2013

Possible Butterfly valve at LS toe.

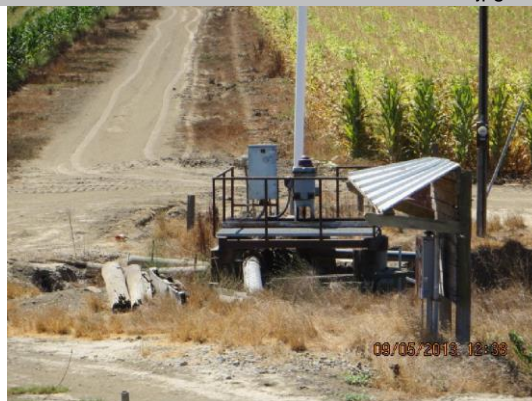
Photo 2 of 3 : UCIP_FA_2018_19435_32992.jpg

Possible connection at pump 150-feet off LS toe.

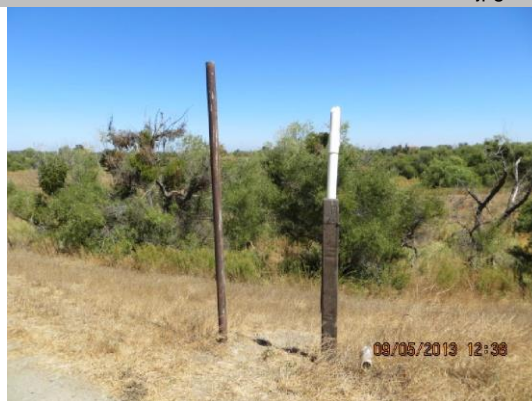
Photo 3 of 3 : UCIP_FA_2018_19435_32991.jpg

Vent on WS shoulder.

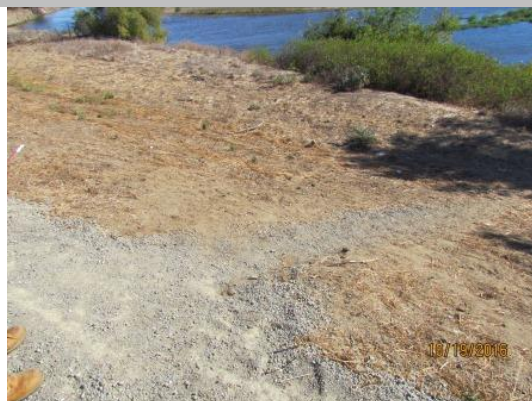
Photo 1 of 1 : FA_2018_RD2085_113_26_20180911_00014.jpg

View of the foot path on the levee slope.

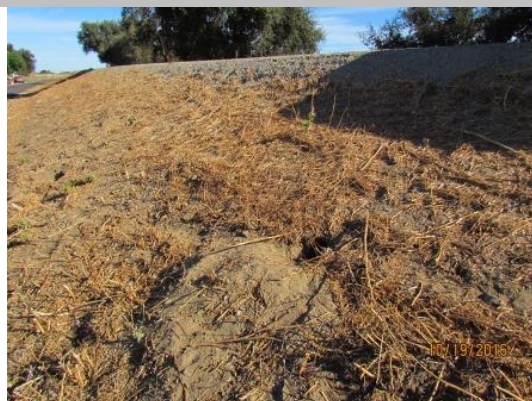
Photo 1 of 1 : FA_2018_RD2085_113_36_20180911_00022.jpg

View of the rodent holes on the levee slope.

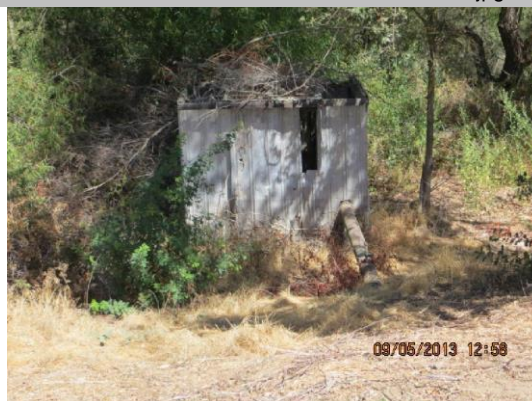
Photo 1 of 3 : UCIP_FA_2018_19443_33002.jpg

Pumphouse and pipe visible on WS toe.

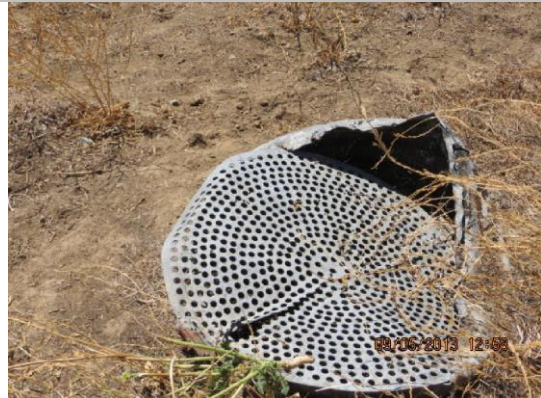
Photo 2 of 3 : UCIP_FA_2018_19443_33001.jpg

Siphon breaker on vent in 24-inch CMP riser on LS shoulder.

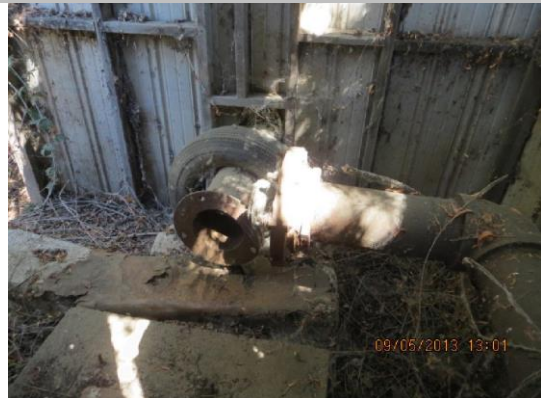
Photo 3 of 3 : UCIP_FA_2018_19443_33000.jpg

Pump missing from pipe in pump house on WS toe.

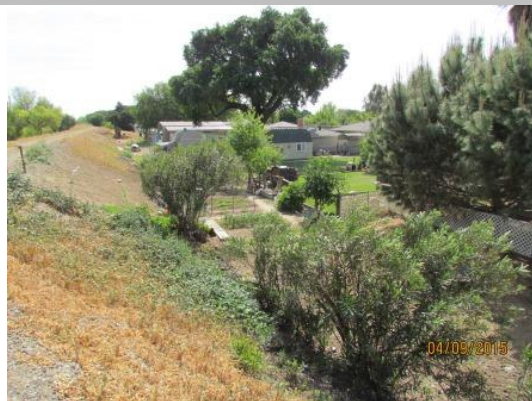
Photo 1 of 2 : FA_2018_RD2085_113_33_20180911_00019.jpg

View of the landscaping at the landside levee slope.

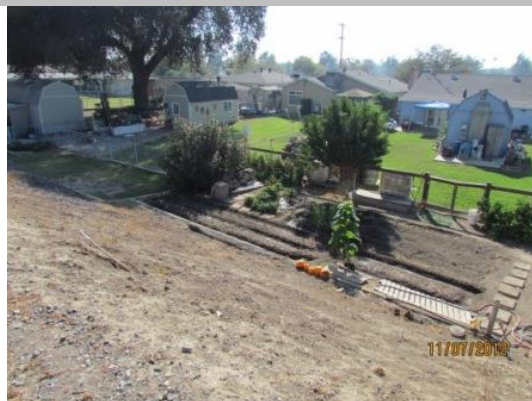
Photo 2 of 2 : FA_2018_RD2085_113_33_20180911_00020.jpg

Updated photo of encroachments on landside toe.

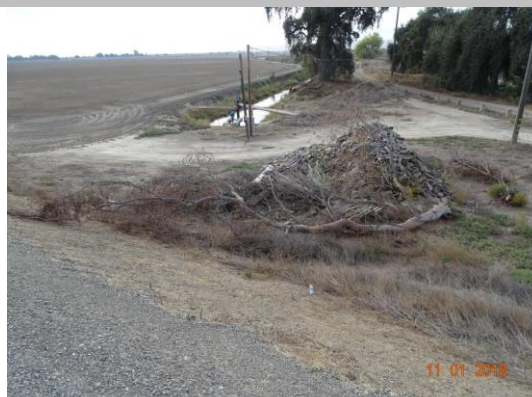
Photo 1 of 1 : FA_2018_RD2085_113_47_20181105_00069.jpg

View of tree limb within the landside easement. Fall 2018.

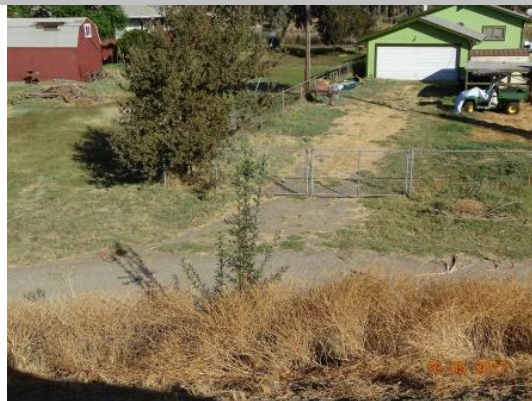
Photo 1 of 1 : FA_2018_RD2085_113_3_20180911_00009.jpg

View of the volunteer tree at the levee toe.

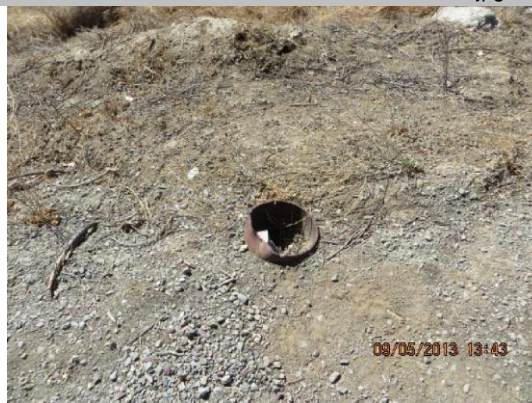
Photo 1 of 3 : UCIP_FA_2018_22290_38020.jpg

Siphon breaker in 10-inch steel riser on LS shoulder.

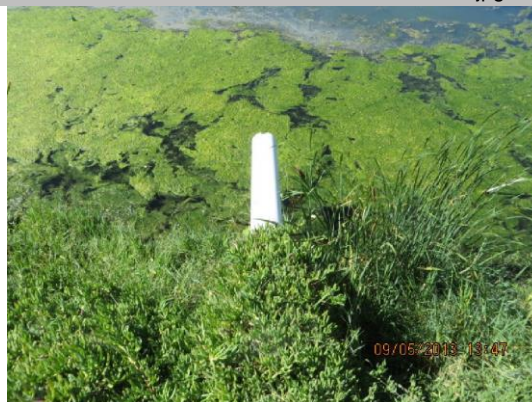
Photo 3 of 3 : UCIP_FA_2018_22290_38018.jpg

Pipe visible at pond outlet off LS toe.

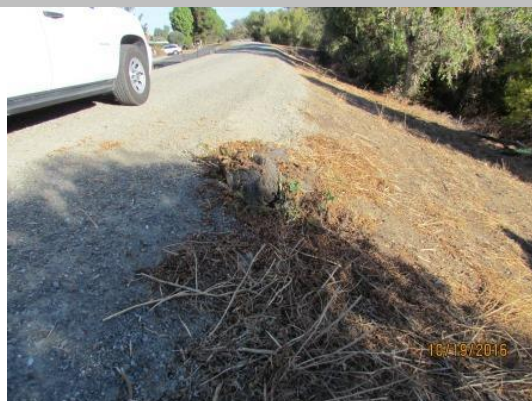
Photo 1 of 1 : FA_2018_RD2085_113_29_20180911_00017.jpg

View of the tree stump.

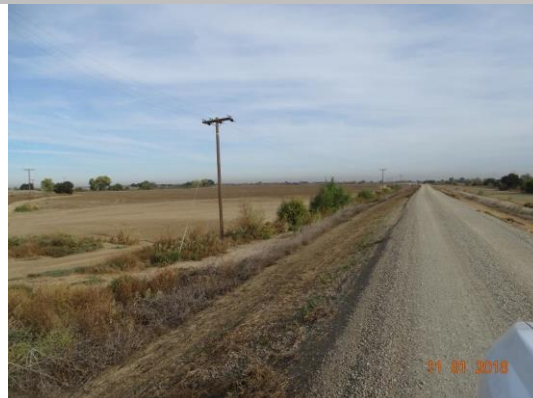
Photo 1 of 1 : FA_2018_RD2085_114_1_20181105_00001.jpg

View of maintained waterside slope. Fall 2018.

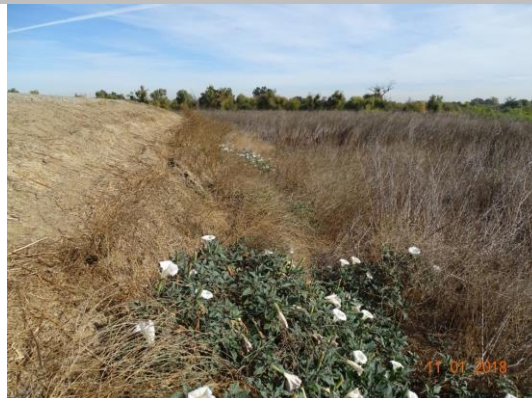
Photo 1 of 4 : FA_2018_RD2085_115_1_20181105_00004.jpg

Updated view of erosion on the waterside slope. Fall 2018.

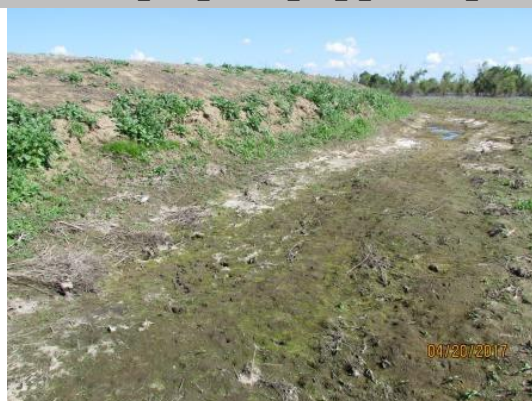
Photo 2 of 4 : FA_2018_RD2085_115_1_20180911_00001.jpg

View of the erosion at the waterside levee toe. Spring 2017.

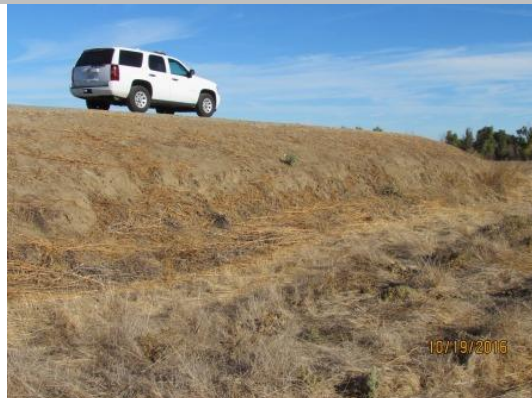
Photo 3 of 4 : FA_2018_RD2085_115_1_20180911_00002.jpg

View of the erosion at the waterside levee toe. Fall 2016.

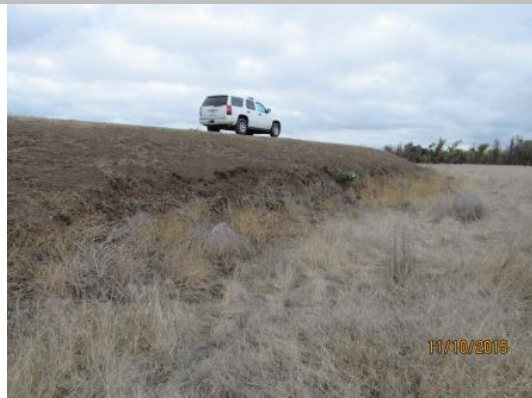
Photo 4 of 4 : FA_2018_RD2085_115_1_20180911_00003.jpg

View of the erosion at the waterside levee toe.
